Manhole Inspection Summary

Manhole # S65M__002MH

Insp Date: **5/14/08 9:51 AM**

Location Address: **1101 Broening Hwy.**

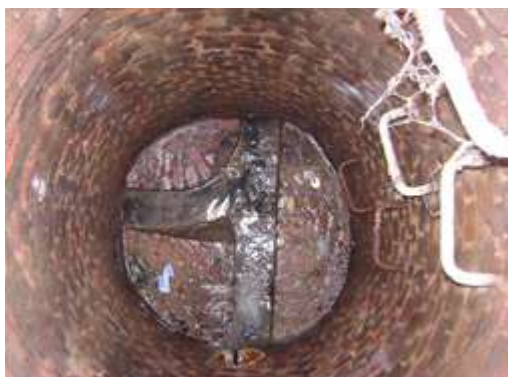
Defect 4

fracture longitudinal 6:00 on incoming drop connection. (Top pipe)

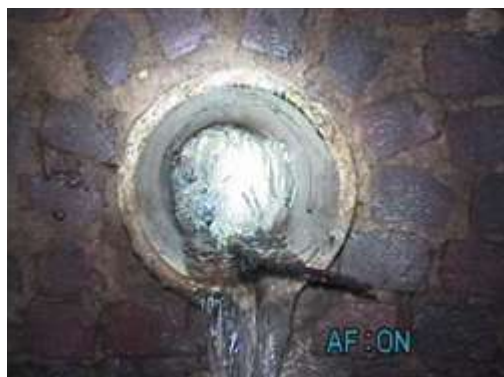
Defect 5

fracture longitudinal 6:00 on incoming drop connection. Difficult to see under flow.

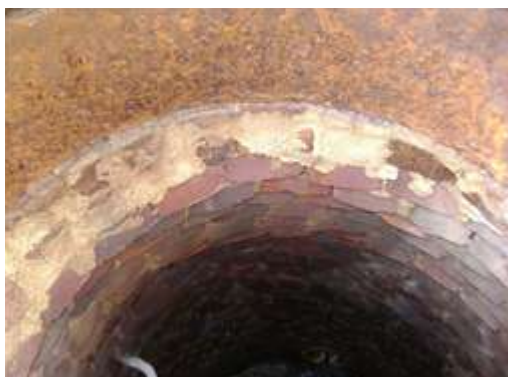
Defect 2

previous repairs in frame adjustment

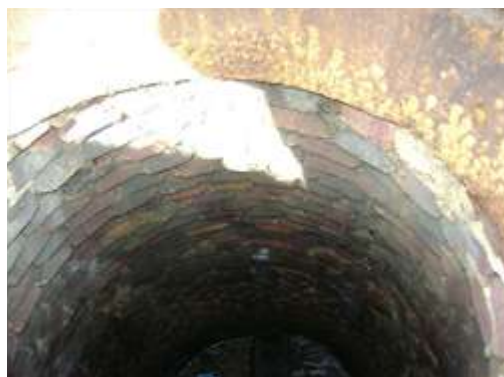
Defect 3

evidence of infiltration in barrel

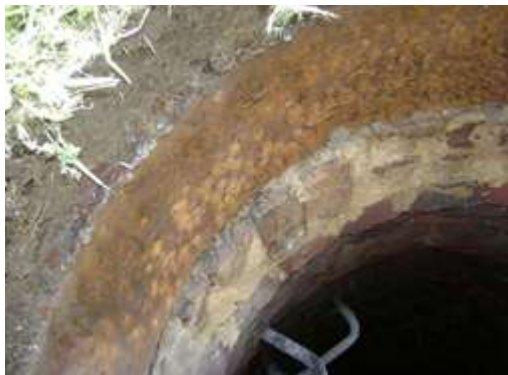
Defect 1

infiltration evidence on frame

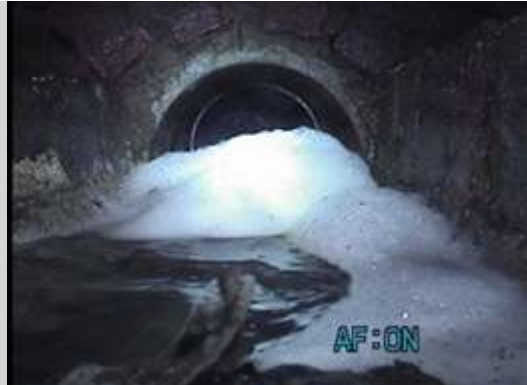
12 O'Clock Outflow

Pipe Height: **8.4** (in.) Rod and Bar (Angled)
Pipe Material: **Clay** ☐ Pipe Lined
Invert Depth: **10.33** (ft.) Flow Characteristics: **Fast**
Deposits: ☐ None ☐ Mud ☒ **Sludge** ☐ **Debris** ☐ Grease
Silt Depth: **0.5** (in.) Deposits Extent: **Light**
Infiltration: **None** Pipe Seal Cond: **Sound**

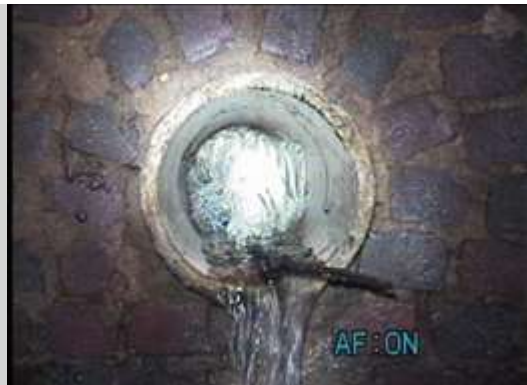
6 O'Clock Inflow

Pipe Height: **8.4** (in.) Rod and Bar (Angled)
Pipe Material: **Clay** ☐ Pipe Lined
Invert Depth: **8.33** (ft.) Flow Characteristics: **Fast**
Deposits: ☐ None ☐ Mud ☐ Sludge ☒ **Debris** ☐ Grease
Silt Depth: **1.5** (in.) Deposits Extent: **Medium**
Infiltration: **None** Pipe Seal Cond: **Sound**

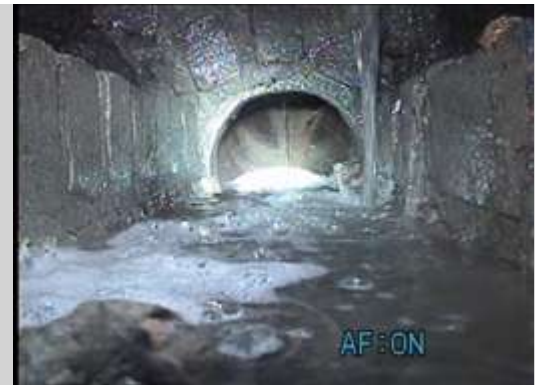
Drop In @ 6 O'Clock

Drop: **Outside** Rod and Bar
Angled: **Yes** Reading: **9.25** (ft.)
Inv Depth: **10.25** (ft.)
Drop Condition: **Clogged**

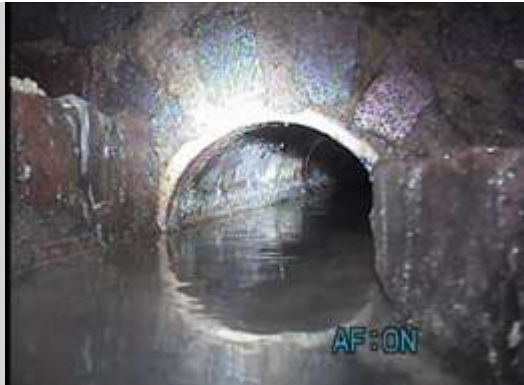
9 O'Clock Inflow

Invert Depth: **10.25** (ft.) Flow Characteristics: **Slow**

Deposits: ☐ None ☐ Mud ☐ Sludge ☒ **Debris** ☐ Grease

Silt Depth: **1** (in.) Deposits Extent: **Light**
